Architectural Survey of Pershing Elementary School, Fort Leonard Wood, Missouri

Sunny E. Adams and Adam D. Smith

August 2013

Final Report

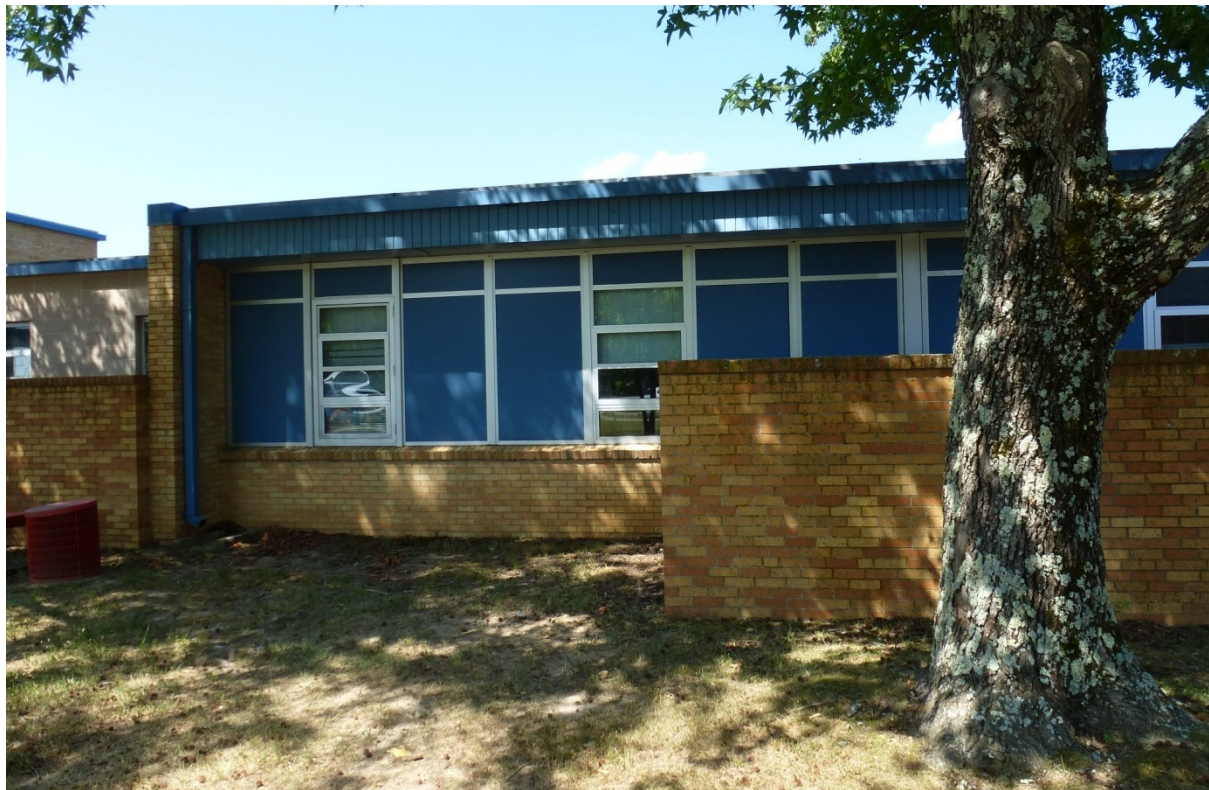
Photo 49. East elevation of the original school building with modified window pattern of replacement bright aluminum windows and panel inserts (ERDC-CERL, 2012).

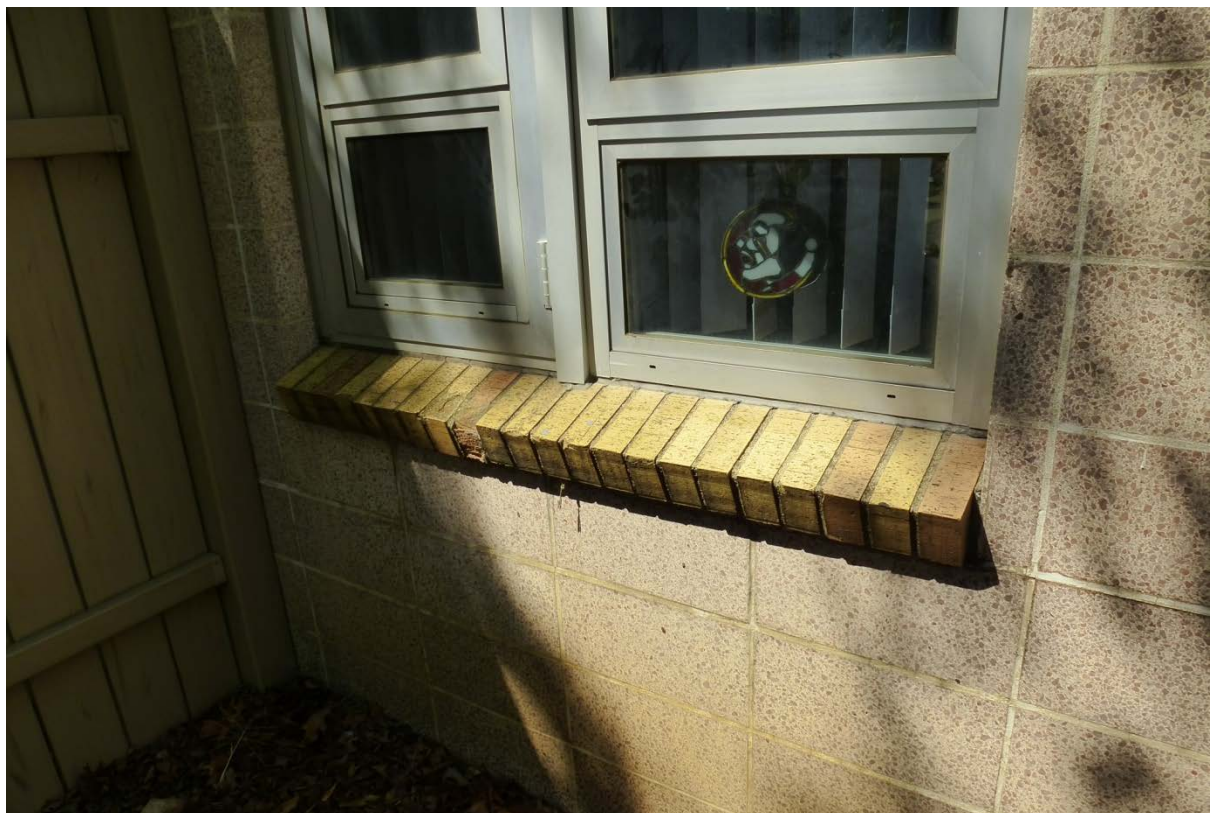
Photo 52. Replacement window with original brick windowsill near the main entry on the east elevation (ERDC-CERL, 2012).

On the right side of the main entry are two replacement windows with brick windowsills (photo 52). The windows are bright aluminum awning windows set into a wall of terrazzo faced block (photo 51). To the right of these two windows are two of the original classrooms. The original wall of windows have been removed and replaced with a combination of porcelain enamel metal panels and bright aluminum windows (photo 48). The portion of the east elevation that projects off the original brick exterior is the 1984 addition. The face brick is

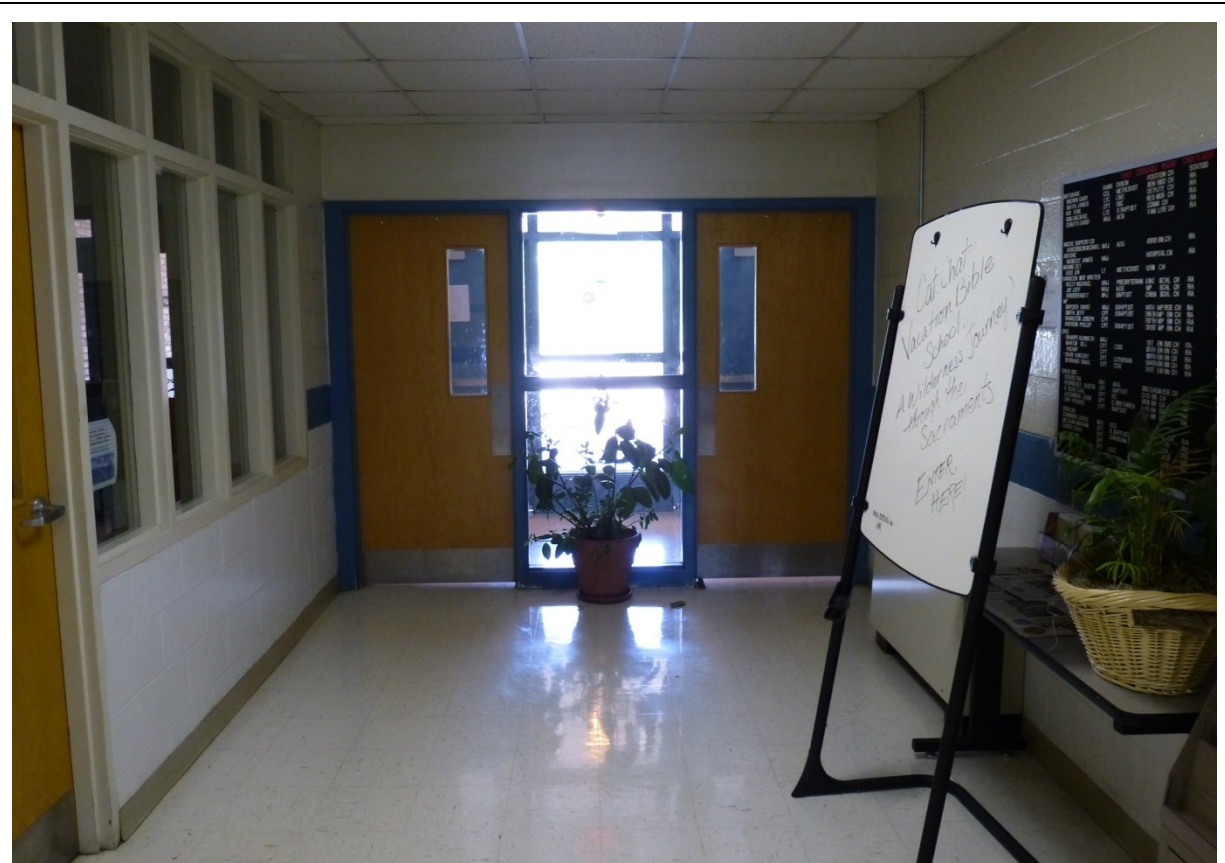
Photo 53. Looking toward the replacement vestibule doors on the east side of the building (original school) (ERDC-CERL, 2012).

Vestibule on the east entry (This vestibule is part of the original design.): The vestibule has two replacement wood doors, each with a narrow glass pane. A two-pane fixed sidelight is located in between the two doors (photo 53). The floor has been replaced and is currently covered with vinyl tiles. This vestibule is part of the original design.

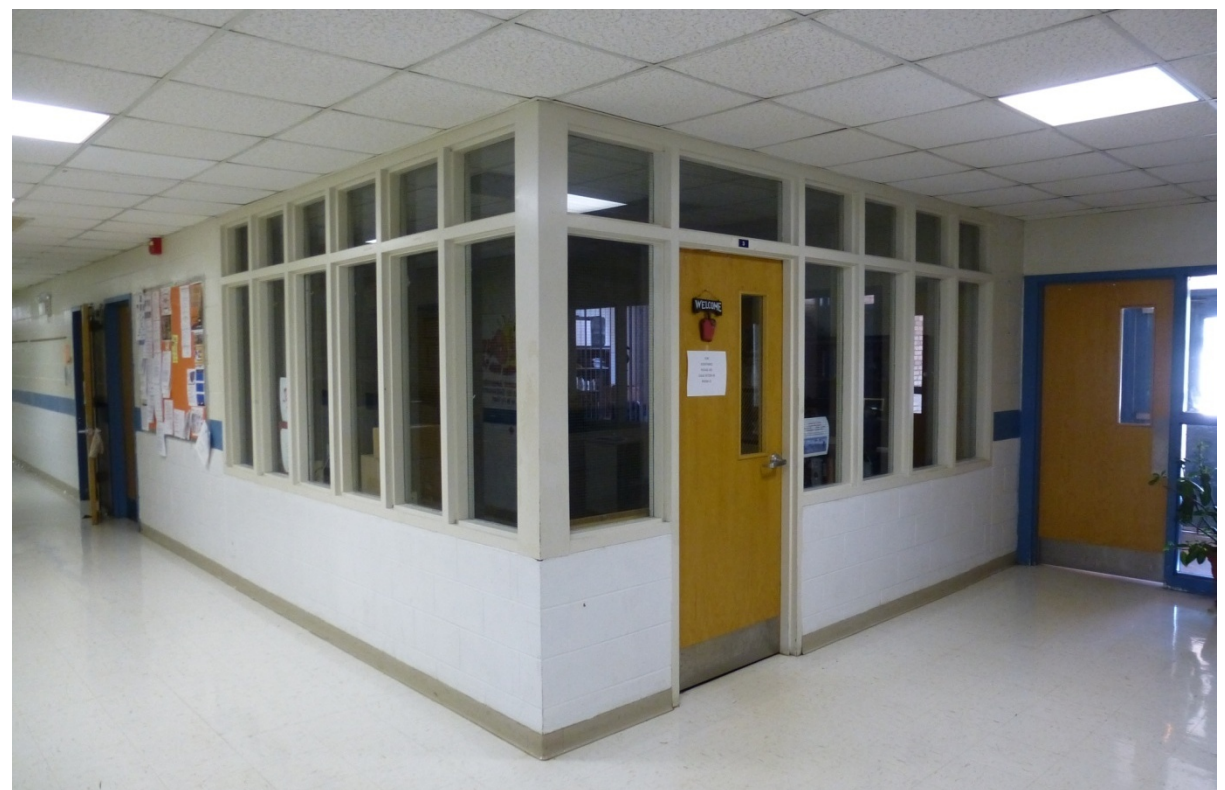
Photo 54. Remodeled office area with new glass wall (added in 1984) (ERDC-CERL, 2012).

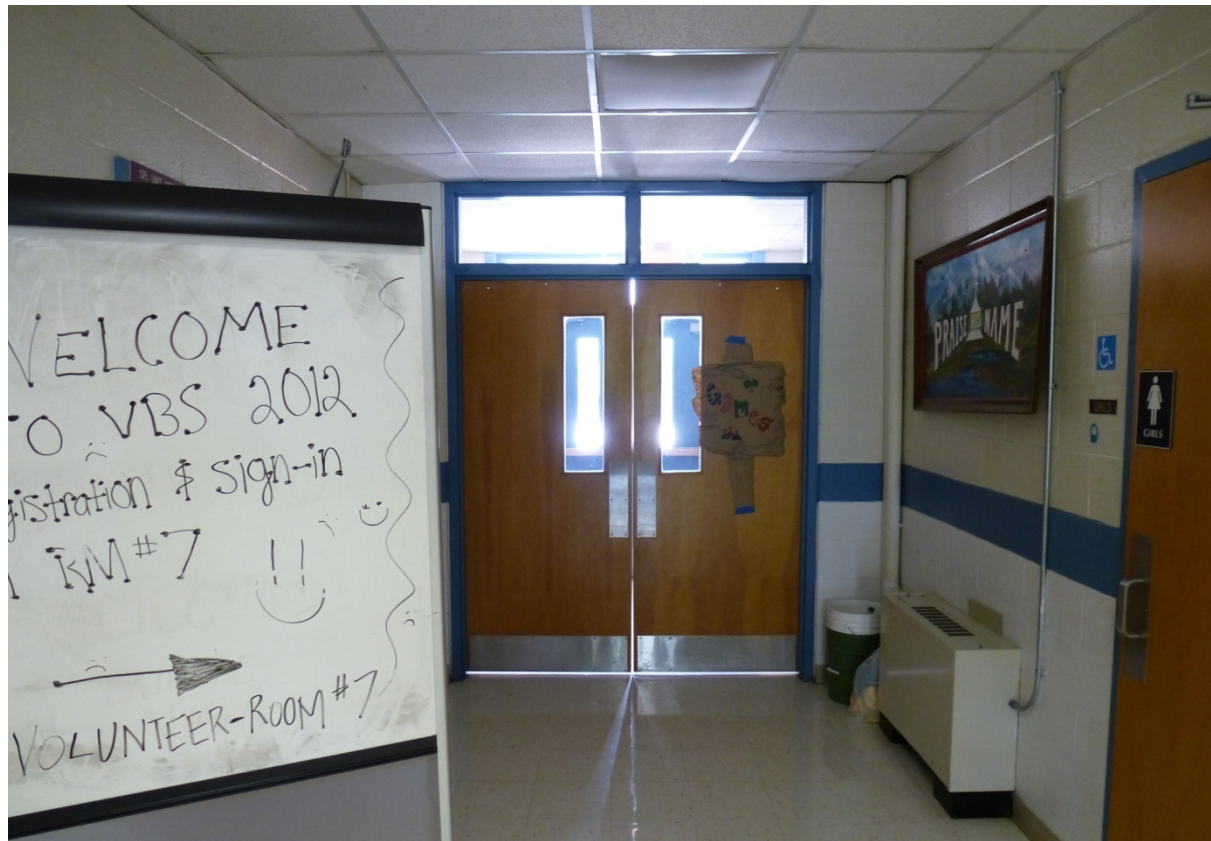
Photo 57. Looking toward replacement vestibule doors on the west side of the building (original school) (ERDC-CERL, 2012).

Vestibule on the west entry (This vestibule is part of the original design.): The vestibule has replacement two replacement wood doors each with a narrow glass pane. Two fixed transoms are located above the doors (photo 57). The floor has been replaced and is currently covered with vinyl tiles. This vestibule is part of the original design.

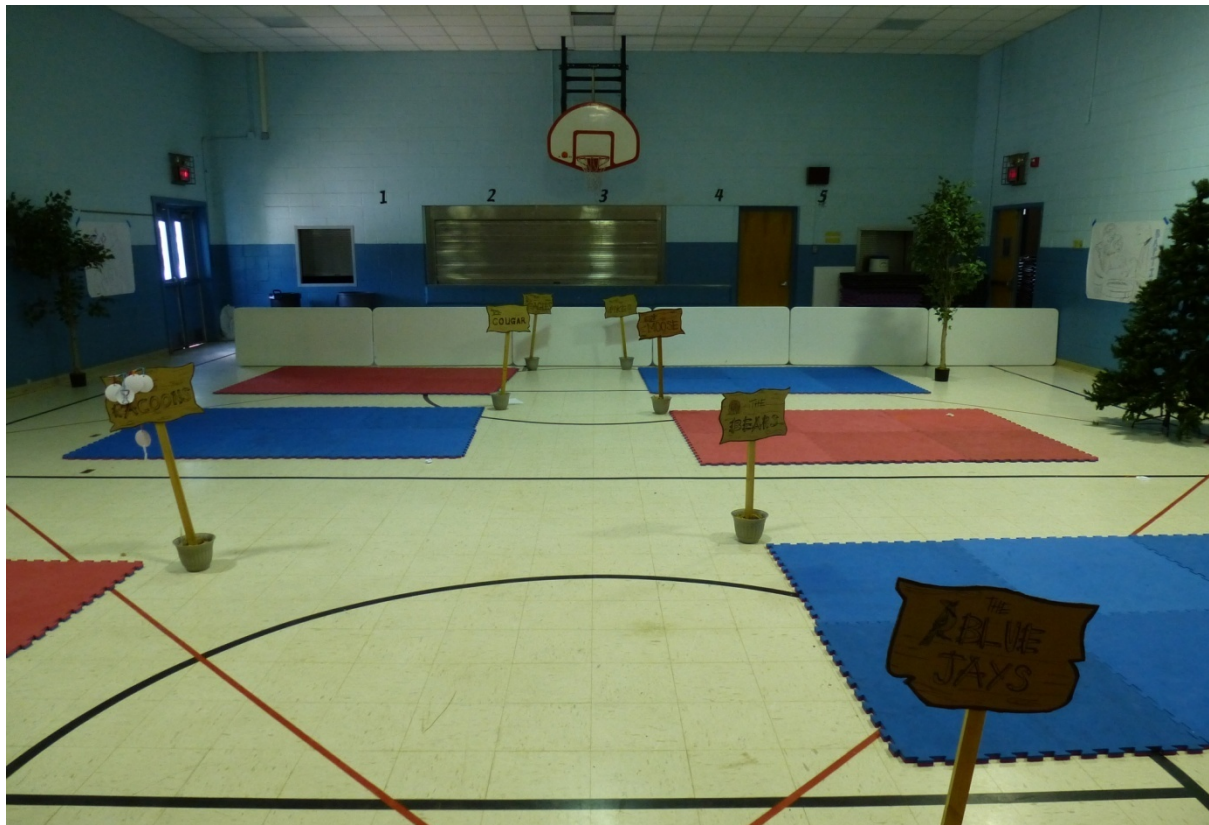
Photo 65. Looking south in the multi-purpose room with replacement flooring and acoustic drop-tile ceiling (original school) (ERDC-CERL, 2012).

Multi-purpose room: The multi-purpose room is a large double-height space. Most of the space has been modified with new flooring, replacement light fixtures, an acoustical drop-tile ceiling, and replacement wood doors (photos 65 and 74). Two sets of replacement wood doors provide access into the multi-purpose room from the corridor (photo 60), while a set of replacement metal doors, located on the east wall provide access to the outside.

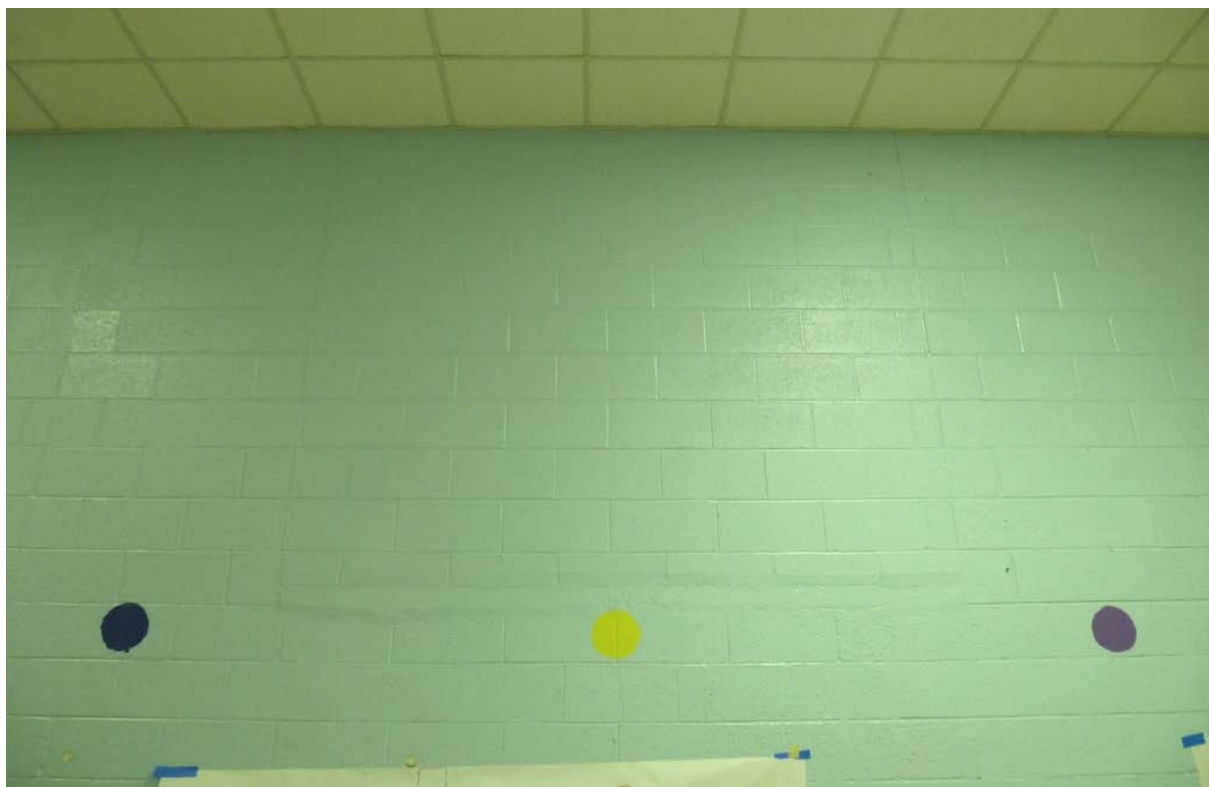
Photo 66. Looking toward east wall in multi-purpose room where the original windows were removed and the openings filled with concrete block (original school) (ERDC-CERL, 2012).

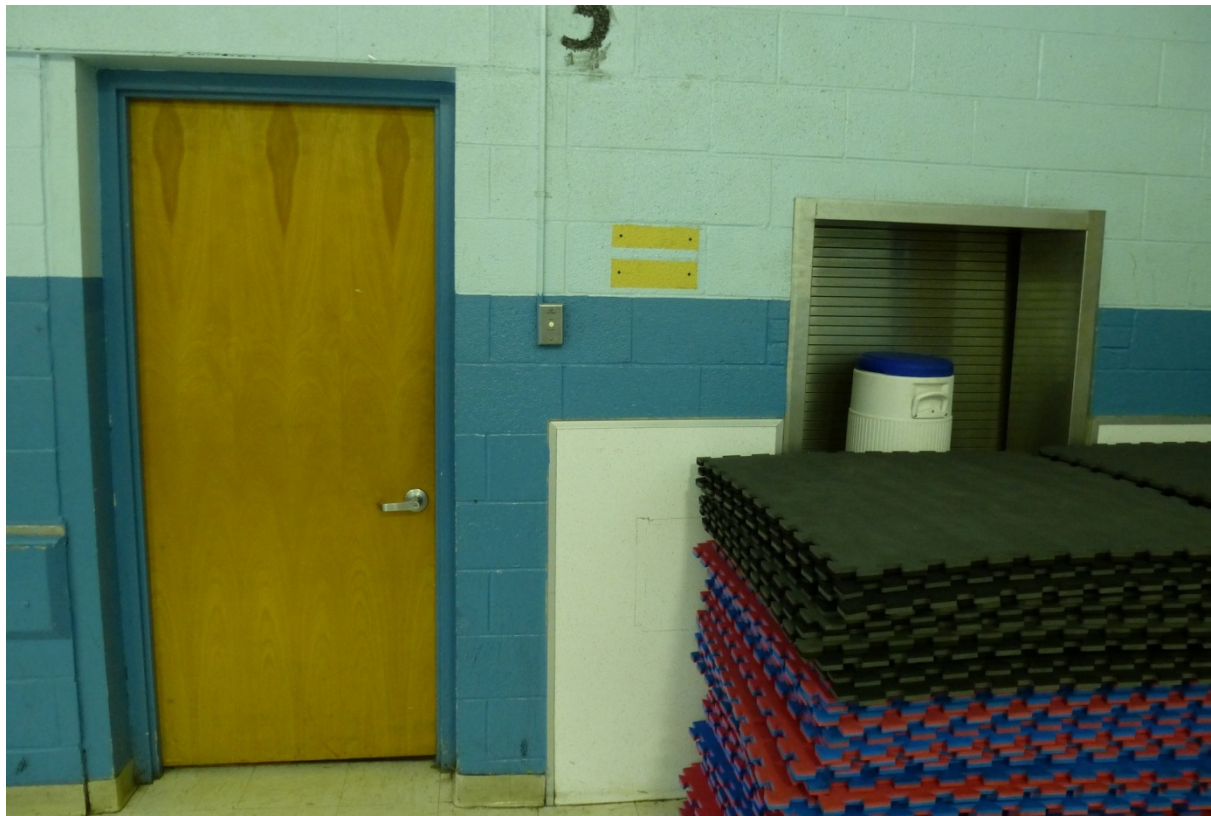
Photo 69. Replacement door leading into the kitchen (original school) (ERDC-CERL, 2012).

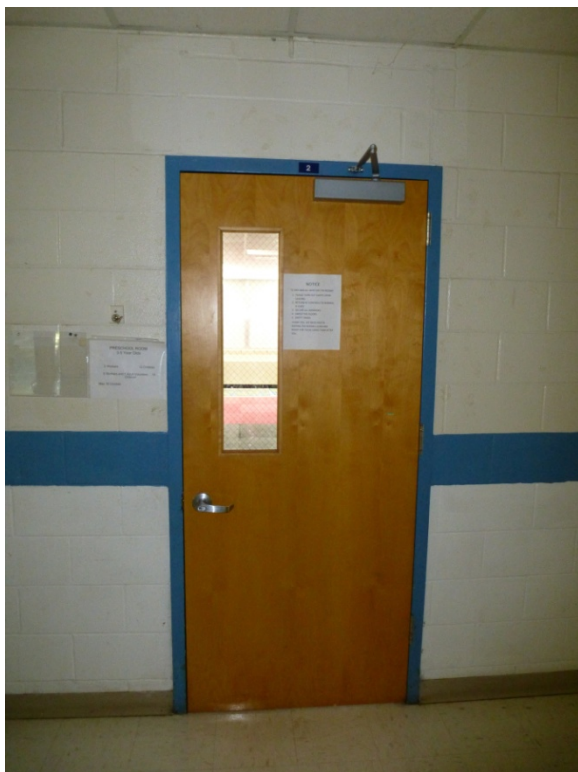
Photo 76. Replacement door into a kindergarten room (original school) (ERDC-CERL, 2012).

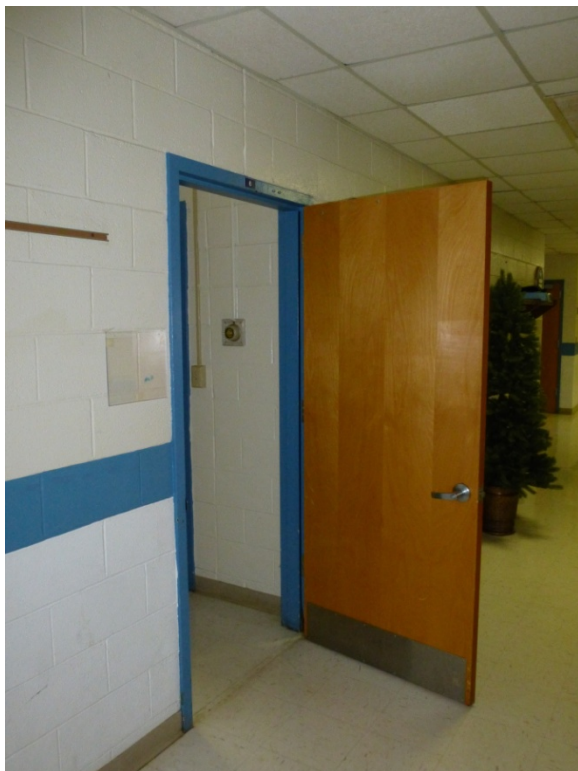
Photo 84. Replacement classroom door (original school) (ERDC-CERL, 2012).

Teacher Workroom/Nurse Room: These rooms are now used as offices. Each room has a replacement vinyl tile flooring, acoustic drop-tile ceiling, replacement light fixtures, concrete block walls, and replacement wood entry doors that provide access from the corridor (photos 84 and 85).

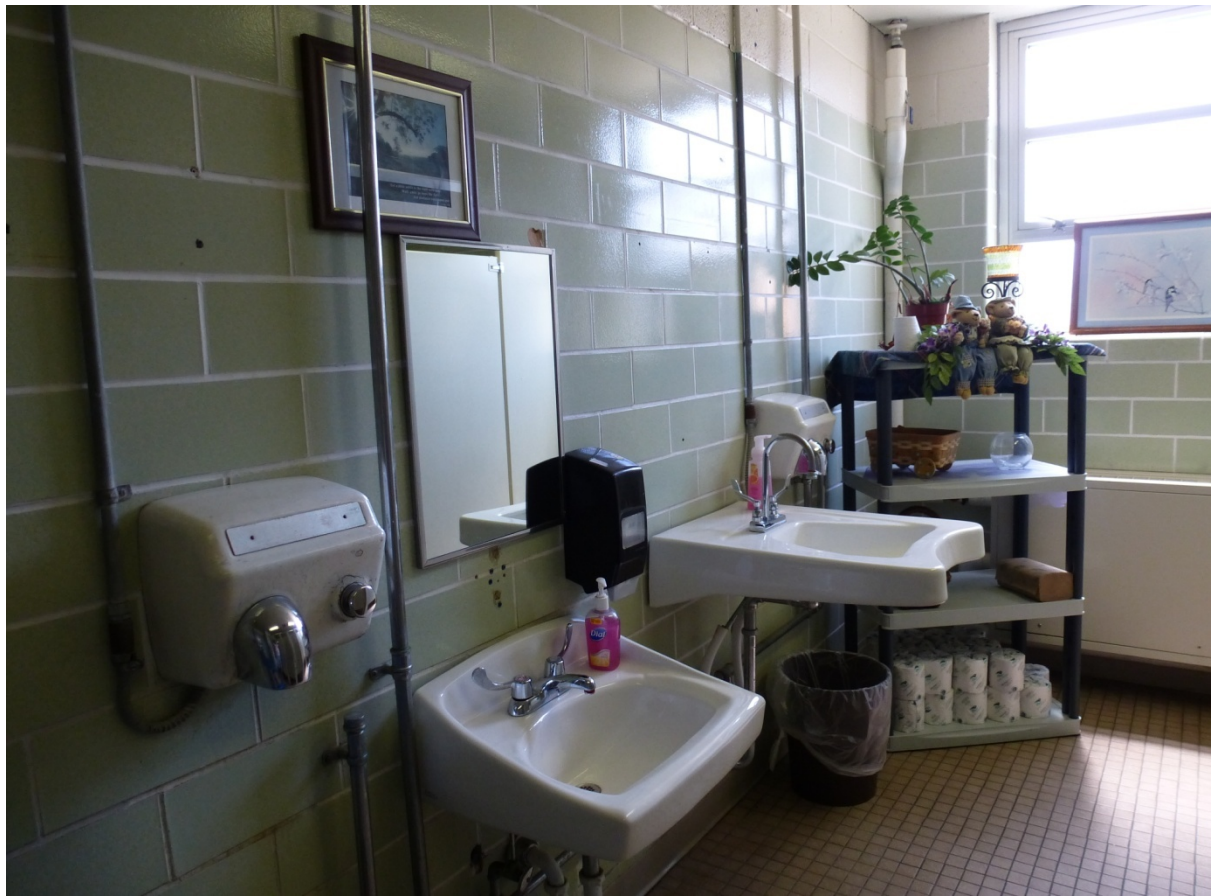
Photo 87. Girls' restroom with replacement sinks (original school) (ERDC-CERL, 2012).

Girls’ Restroom: The restroom consists of the original mosaic tile floor, original glazed-tile walls, and original toilets. There is a single replacement window located on the west wall (photos 86–88).

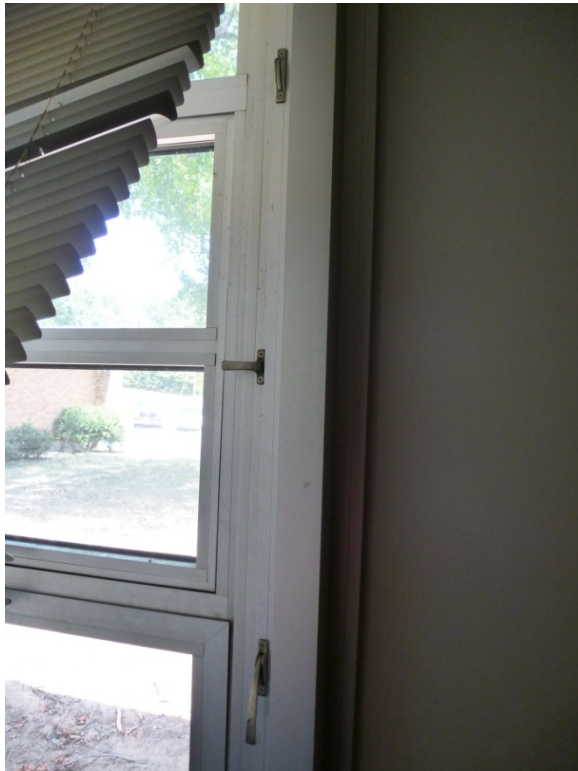
Photo 93. Closeup of replacement window hardware (original school) (ERDC-CERL, 2012).

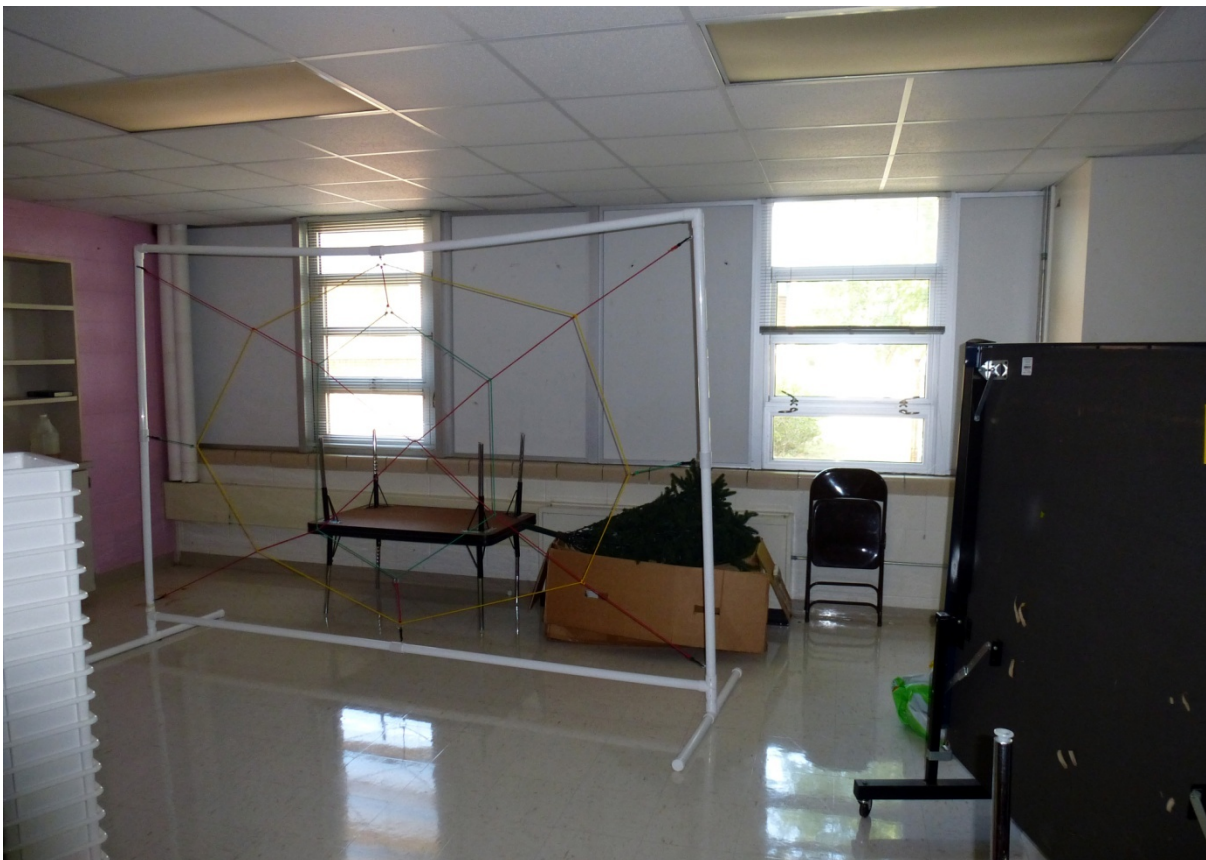
Photo 94. Interior of classroom looking at replacement windows, floors, and ceiling (original school) (ERDC-CERL, 2012).

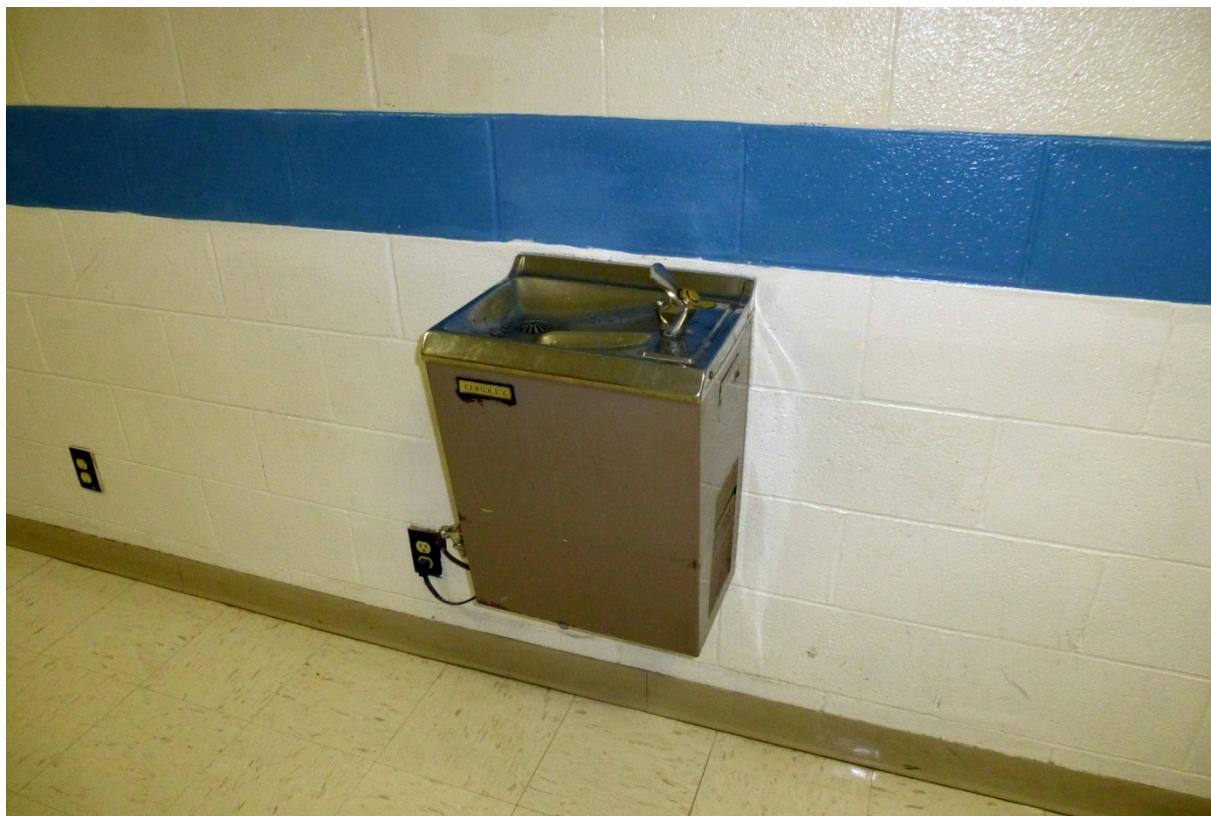
Photo 96. Replacement water fountain in original corridor (original school) (ERDC-CERL, 2012).

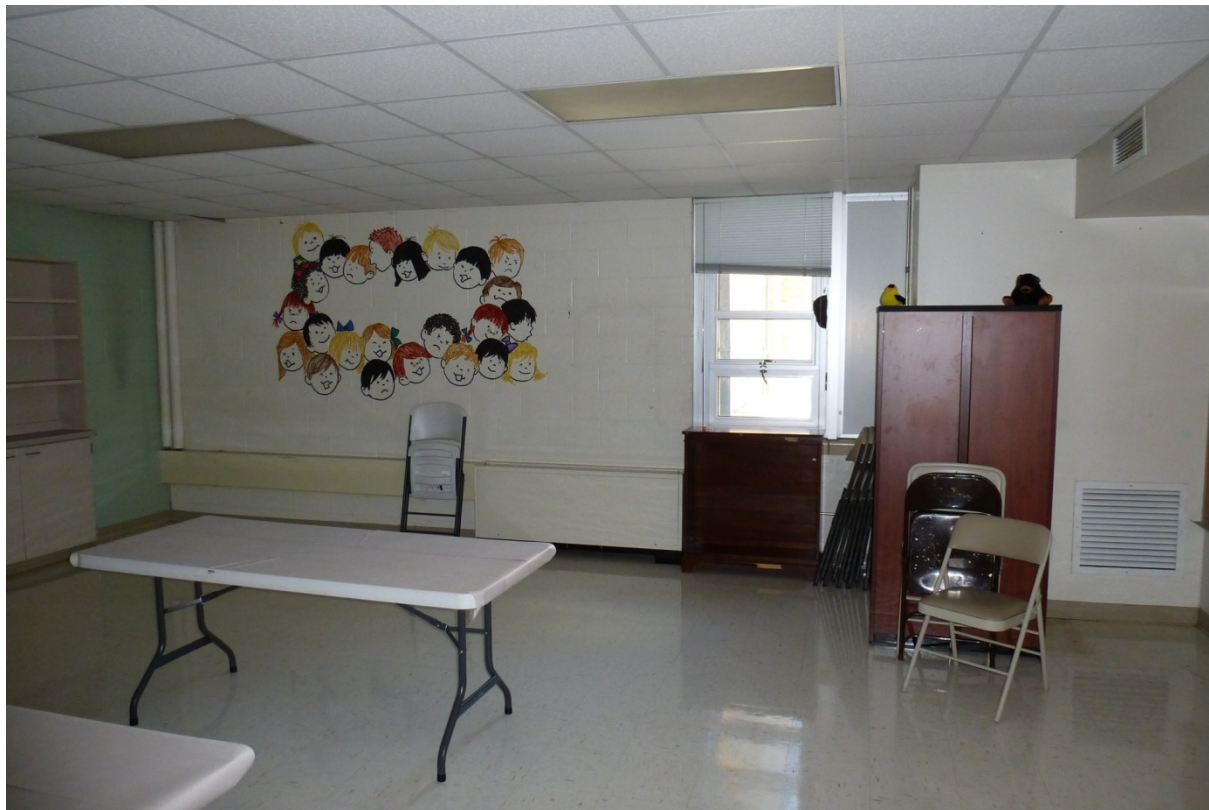
Photo 97. Classroom with replacement windows, floor, and ceiling (original school) (ERDC-CERL, 2012).

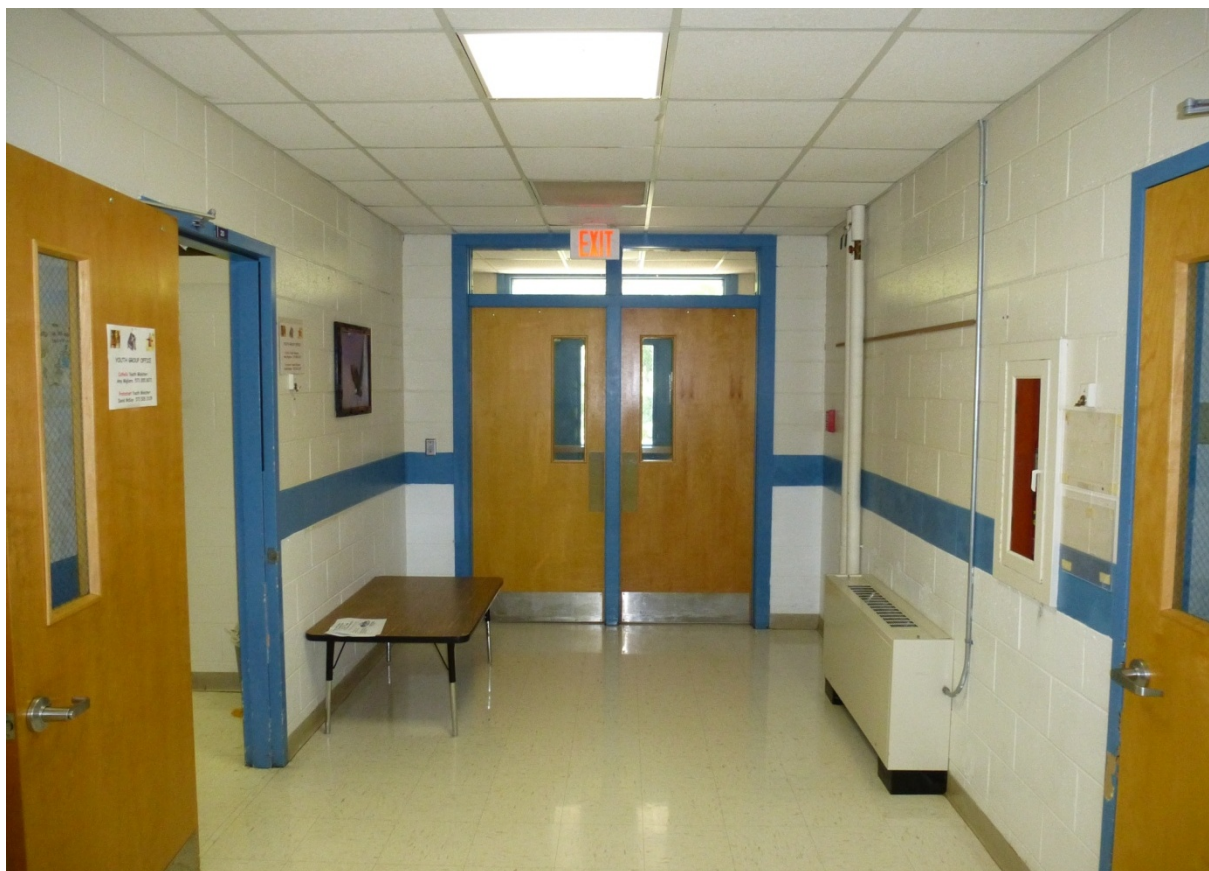
Photo 111. Replacement vestibule doors at the north end of the 1984 addition (ERDC-CERL, 2012).

Vestibule on the north entry (This vestibule is part of the 1957 addition.): The vestibule has two replacement wood doors, each with a narrow glass pane. Two fixed transoms are located above the doors (photo 111). The floor has been replaced and is currently covered with vinyl tiles.

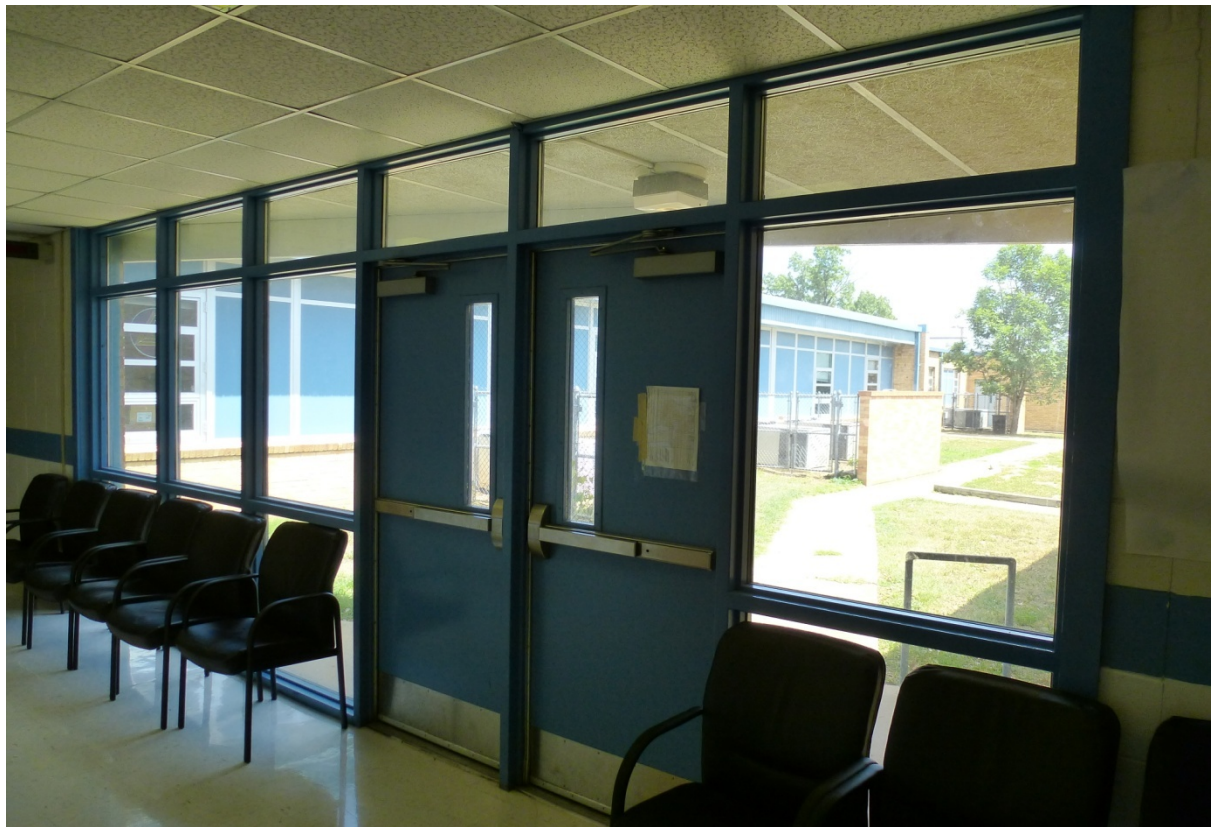
Photo 124. Original 1957 curtain wall with replacement entry doors on the south side of the 1957 west wing addition (ERDC-CERL, 2012).

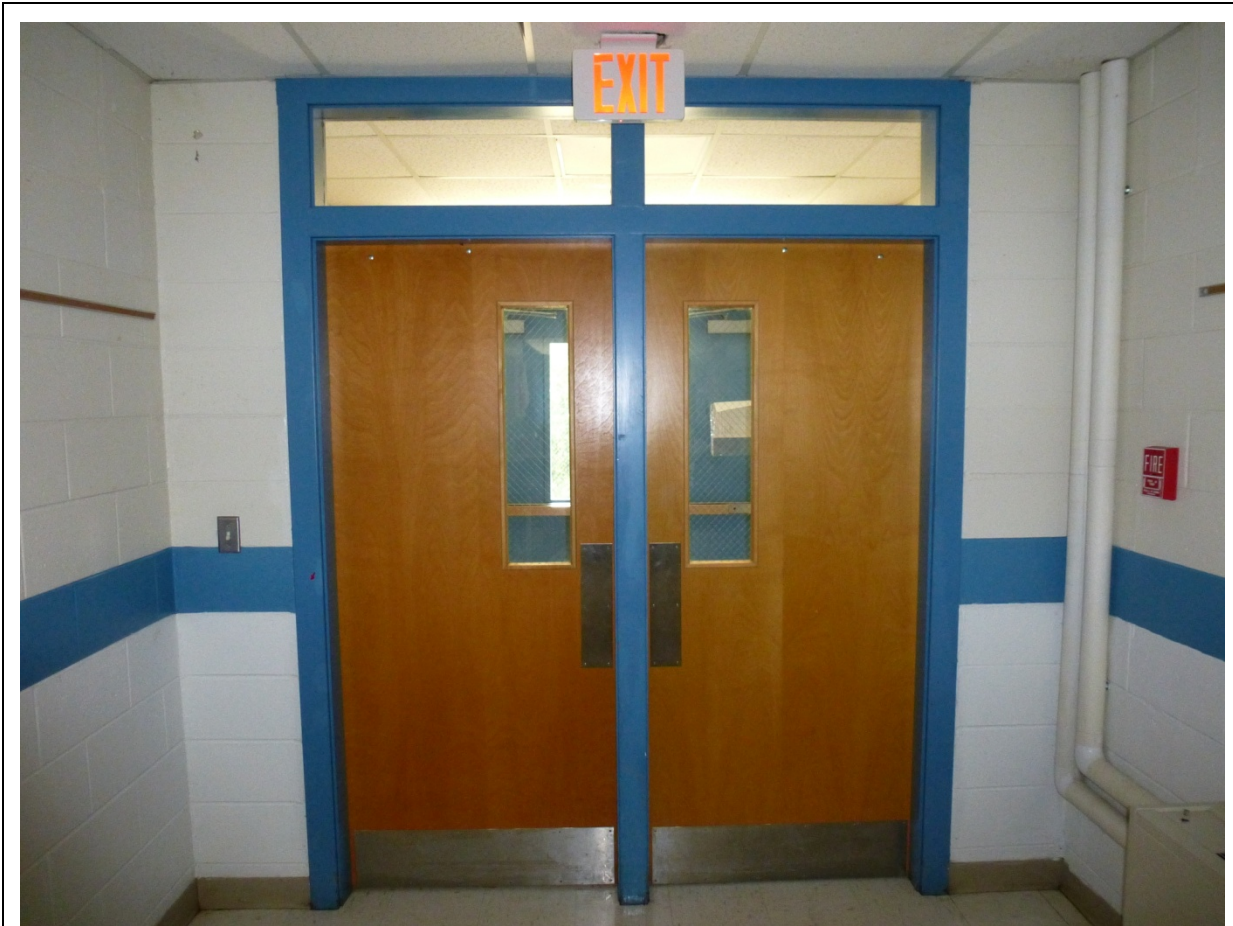
Photo 127. Replacement vestibule doors at the west end of the 1984 addition (ERDC-CERL, 2012).

Vestibule on the west entry (This vestibule is part of the 1984 addition.): The vestibule has two replacement wood doors, each with a narrow glass pane (photo 127). Two fixed transoms are located above the doors. The floor has been replaced and is currently covered with vinyl tiles.

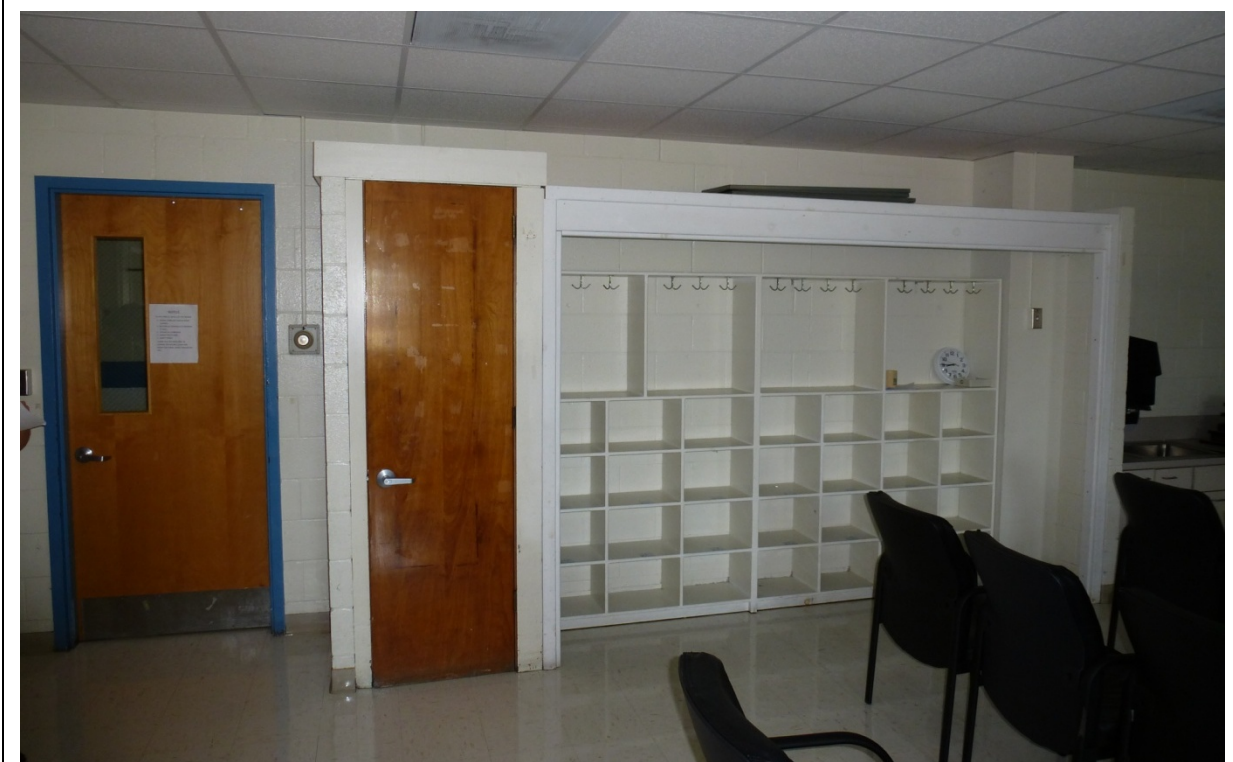
Photo 128. Wardrobe and closet door with replacement hardware in 1957 addition (ERDC-CERL, 2012).

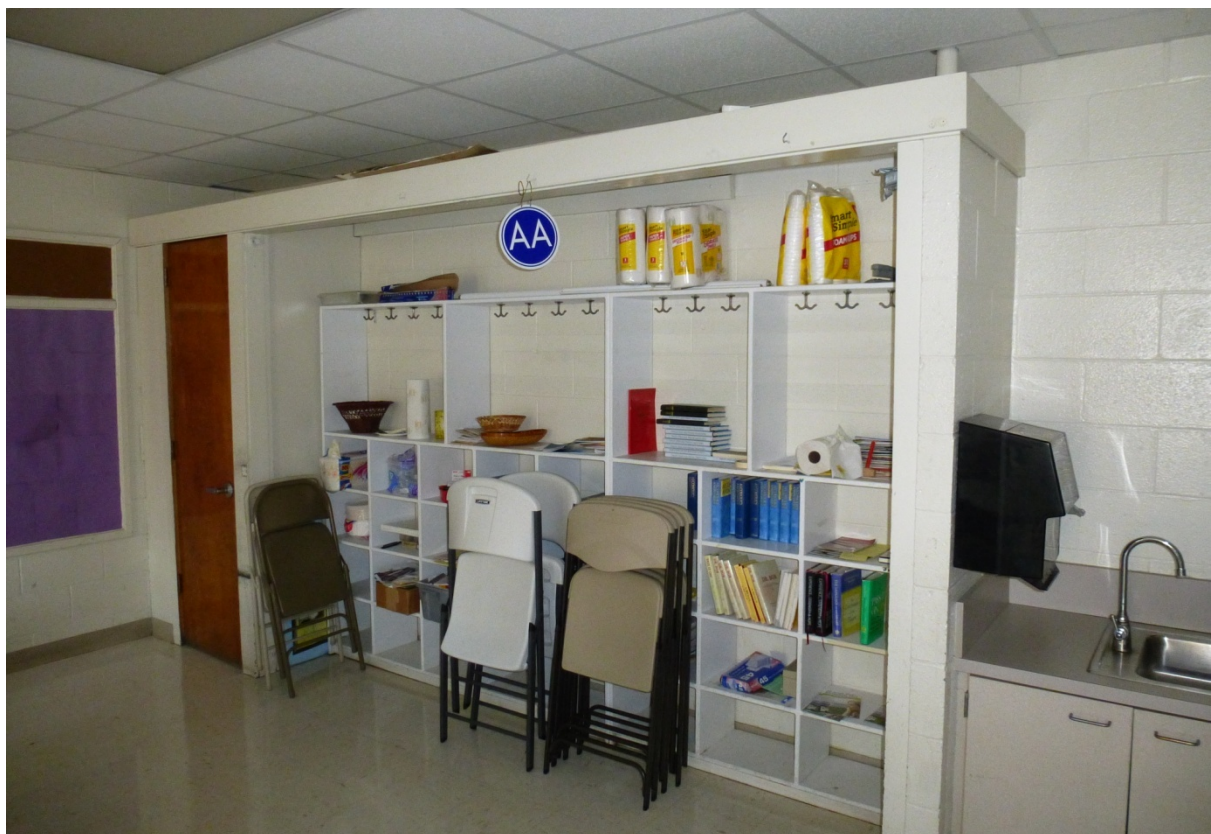
Photo 131. Wardrobe and closet with replacement hardware in classroom (1984 addition) (ERDC-CERL, 2012).
